Hard Times for Small Craft: An Archaeological Survey of the  
Wright's Creek Abandoned Vessel Complex

Vessel 14 – Wright' Creek Abandoned Vessel Complex

Report for North Carolina SeaGrant  
Fund 211274

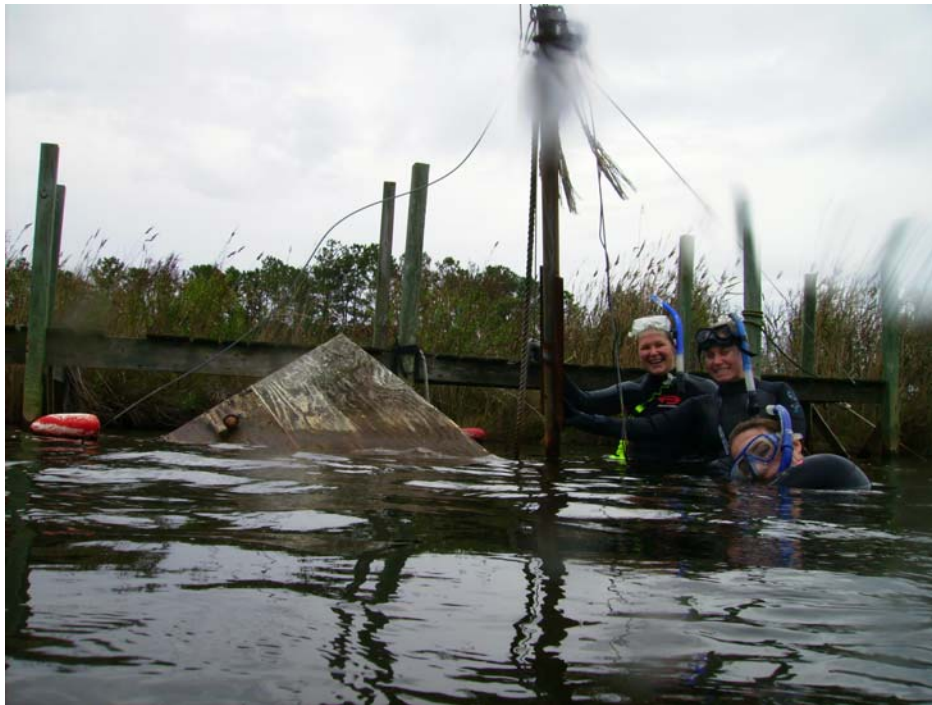
the creek at Contact0017, discovering immediately a small, wooden boat hereafter described as Vessel 14 (Appendix I). The vessel's attitude in the water is precarious as it rests in the silt listing to port, still tied to a decayed dock on its starboard side. Only the starboard corner of the pilothouse and the rusted rigging show above the water's surface (Figure 2).

**Figure 2: Grad students assisting with ground-truthing on Vessel 14. From top: Morgan MacKenzie, Jeanette Hayman, and Lyz Wyllie. Photo by Jacqueline Marcotte October 2008.**

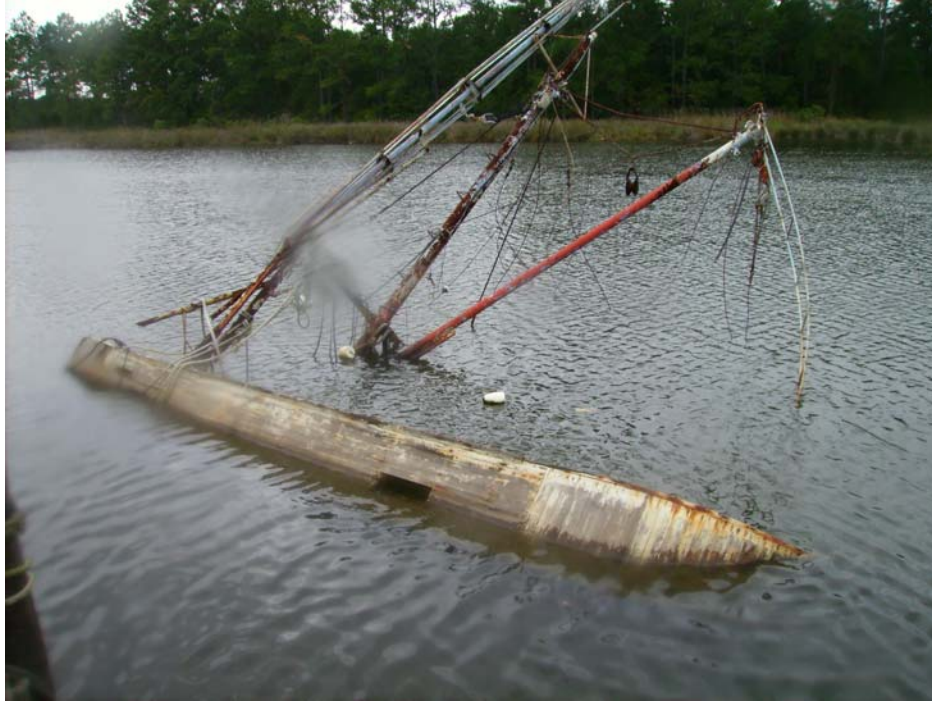
Proceeding directly north, investigators discovered the identity of Contact0018 as Vessel 1 (possible 0026PUR), previously recorded in spring 2008. Continuing on an eastward heading, investigators discovered the source of Contact0014 (Appendix I). This vessel is in a highly deteriorated state, with only a portion of the stern visible above the water, and a large amount of rusted rigging listing dangerously to starboard. During recording of the vessel's stern, large amounts of oil began belching from the vessel, and lines still tied to its stern danced dangerously near investigators in the water. Due to these complexities, the dive safety officer deemed Contact0014 too dangerous to dive or investigate from close proximity (Figure 3).

**Figure 3: Contact0014, abandoned vessel across from Foster's Seafood Landing.**

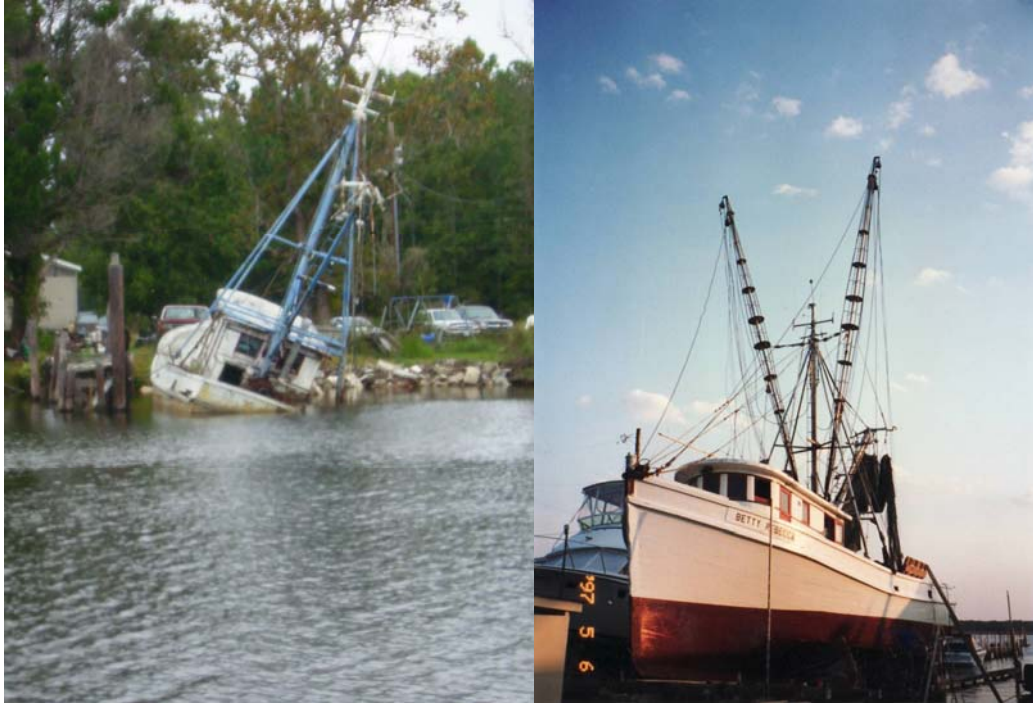
Continuing in a northeast heading, investigators encountered the source of Contact0021, an abandoned vessel located in front of Foster's Seafood (Appendix I). This vessel is the *Betty Rebecca*, a 54 ft. wooden trawler built by Major Wilson Foster, and area resident, in the 1970s (Figure 4). The final two anomalies, Contact0007 and Contact 0008, were tracked to the south prong of Wright's Creek (Appendix I). Unfortunately, they lie beneath two working fishing vessels, the *Brittany Faye* and *Cathy Gail*. For this reason, the dive safety officer allowed no further investigation of the anomalies, which appear as curious, almost oblong shapes in the sonar image.

**Figure 4: The *Betty Rebecca*, built by Major Wilson Foster in the 1970s. Left: *Betty Rebecca* awash during October ground-truthing, photo by Jacqueline Marcotte. Right: *Betty Rebecca* in 1997, photo courtesy Captain Carl Wilson Foster.**

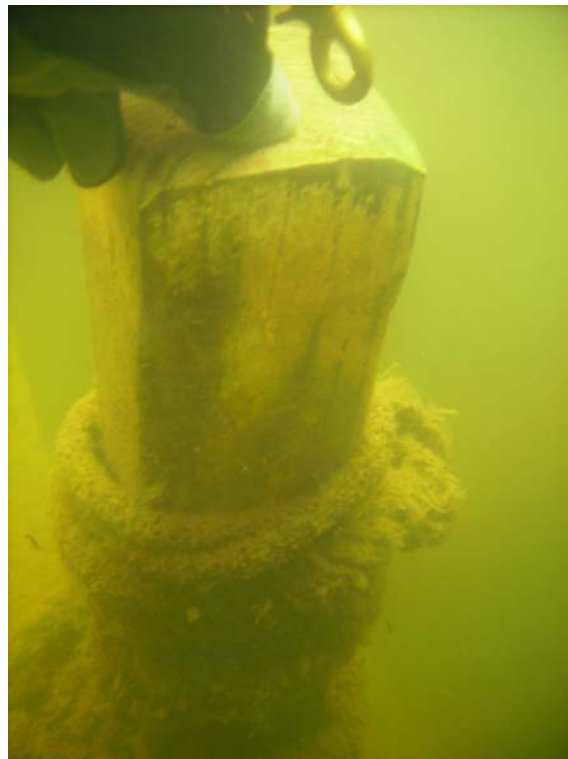
A sampson post sits approximately 3.6 ft. abaft the stem, with line still attached around its body (Figure 6). The remains of a raised forward deck span the expanse between the stem and the forward part of the sampson post, floating unattached to port or starboard planking. The vessel has a raised deck with longitudinal planking at its transom stern section. In addition, the rub-rails or guards have a slight, rounded flair. The pilothouse is located forward midships, approximately 5.2 ft. feet from the stempost.

**Figure 6: Vessel 14's sampson post located in the forward section 3.6 ft. abaft the stempost. Note the aft edge of the raised decking to the left.**

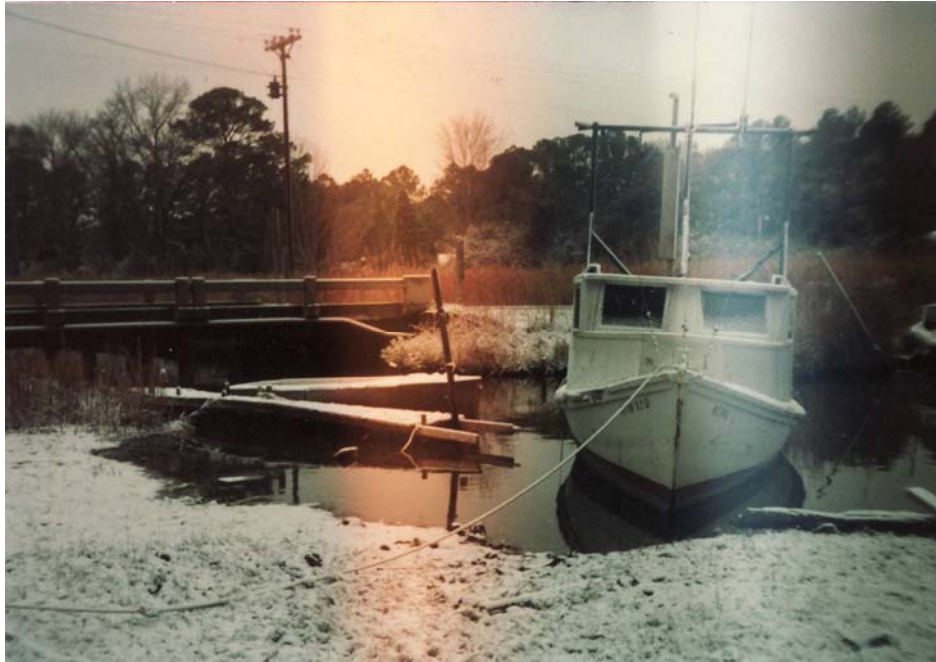
The historic photograph of Vessel 14 yields views of the vessel's bow, hull, and pilothouse, recording the vessel's condition sometime prior to discard (Figure 6). The vessel's rigging appears in tact, attached to the stempost. Wear is present on both the stempost of Vessel 14, and the starboard rub-rail, as large gashes expose unpainted wood. A sampson post is visible some distance abaft the stempost, with line wrapped around it securing the vessel to shore. The

**Figure 7: Vessel 14 in working condition, built by Major Wilson Foster, a Wright's Creek resident and boatbuilder.**

There is no known abandonment date for this vessel, but it appears to be in an advanced state of deterioration, comparable to vessels surveyed near Schoolhouse Landing in spring 2008. Placement assurance can be seen in the form of lines still attaching the sunken vessel to its decaying dock (Figure 7). The vessel's forward, raised deck is deteriorated, only a small portion remains attached to the stempost.

The lack of rigging remaining on the vessel, and its lack of a motor may in fact demonstrate salvage of gear and equipment before purposeful abandonment. For the purposes of this discussion, abandonment of a vessel is defined as one that has been "relinquished, left, or given up by the lawful owner without the intention to later resume any right or interest in the vessel" (Hills 2007:21). Salvage is an example of cultural transforms occurring in the

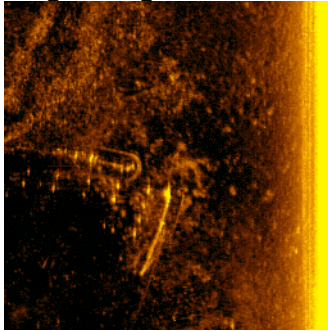
### Contact0007

- Sonar Time at Target: 08/07/2008 19:18:28
- Click Position (Lat): 35.4091532
- Click Position (Lon): -76.5933822
- Map Projection: WGS 1984 UTM, Zone 18 North, Meter
- Click Position (X): 355,322.52
- Click Position (Y): 3,919,583.92
- Acoustic Source File: C:\Users\admin\Desktop\Pungo20080807\XTF\LINE-1-024.XTF
- Ping Number: 4433
- Range to Target: 20.54 Meters
- Fish Height: 1.46 Meters
- Event Number: 0
- Line Name: LINE-1-024
- Area / Block:

Target Description:  
Target Height = 0.00 Meters  
Target Length: 10.60 Meters  
Target Shadow: 0.00 Meters  
Target Width: 3.97 Meters

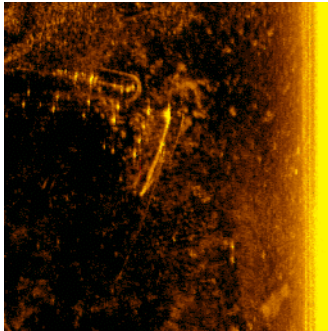
### Contact0008

- Sonar Time at Target: 08/07/2008 19:18:24
- Click Position (Lat): 35.4090775
- Click Position (Lon): -76.5934464
- Map Projection: WGS 1984 UTM, Zone 18 North, Meter
- Click Position (X): 355,316.56
- Click Position (Y): 3,919,575.62
- Acoustic Source File: C:\Users\admin\Desktop\Pungo20080807\XTF\LINE-1-024.XTF
- Ping Number: 4287
- Range to Target: 14.56 Meters
- Fish Height: 1.46 Meters
- Event Number: 0
- Line Name: LINE-1-024
- Area / Block:

Target Description:  
Target Height = 0.00 Meters  
Target Length: 9.53 Meters  
Target Shadow: 0.00 Meters  
Target Width: 2.33 Meters

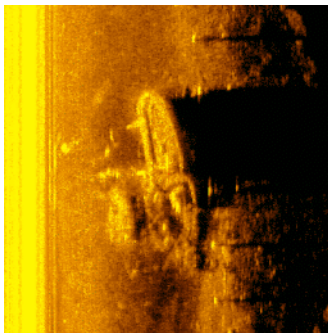
### Contact0014

- Sonar Time at Target: 08/07/2008 17:50:22
- Click Position (Lat): 35.4115387
- Click Position (Lon): -76.6015282
- Map Projection: WGS 1984 UTM, Zone 18 North, Meter
- Click Position (X): 354,587.10
- Click Position (Y): 3,919,860.47
- Acoustic Source File: C:\Users\admin\Desktop\Pungo20080807\XTF\LINE-1-012.XTF
- Ping Number: 4621
- Range to Target: 10.58 Meters
- Fish Height: 1.46 Meters
- Event Number: 0
- Line Name: LINE-1-012
- Area / Block:

Target Description:  
Target Height = 0.60 Meters  
Target Length: 13.38 Meters  
Target Shadow: 7.62 Meters  
Target Width: 3.34 Meters

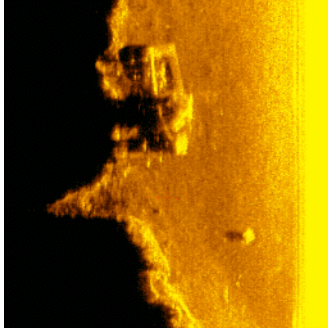
#### Contact0017

- Sonar Time at Target: 08/07/2008 18:35:21
- Click Position (Lat): 35.4101989
- Click Position (Lon): -76.6032412
- Map Projection: WGS 1984 UTM, Zone 18 North, Meter
- Click Position (X): 354,429.14
- Click Position (Y): 3,919,714.38
- Acoustic Source File:  
C:\Users\admin\Desktop\Pungo20080807\XTF\LINE-1-018.XTF
- Ping Number: 2244
- Range to Target: 11.65 Meters
- Fish Height: 1.46 Meters
- Event Number: 0
- Line Name: LINE-1-018
- Area / Block:

Target Description:  
Target Height  $\geq$  0.33 Meters  
Target Length: 6.13 Meters  
Target Shadow: 3.52 Meters  
Target Width: 2.50 Meters

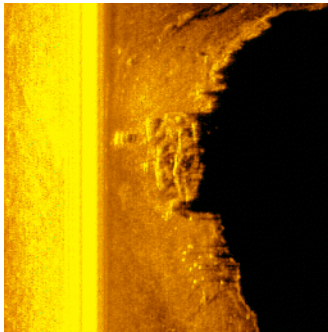
#### Contact0018

- Sonar Time at Target: 08/07/2008 17:47:05
- Click Position (Lat): 35.4106469
- Click Position (Lon): -76.6035043
- Map Projection: WGS 1984 UTM, Zone 18 North, Meter
- Click Position (X): 354,406.05
- Click Position (Y): 3,919,764.46
- Acoustic Source File:  
C:\Users\admin\Desktop\Pungo20080807\XTF\LINE-1-011.XTF
- Ping Number: 27138
- Range to Target: 5.97 Meters
- Fish Height: 1.46 Meters
- Event Number: 0
- Line Name: LINE-1-011
- Area / Block:

Target Description:  
Target Height  $\geq$  0.40 Meters  
Target Length: 9.81 Meters  
Target Shadow: 2.39 Meters  
Target Width: 3.42 Meters

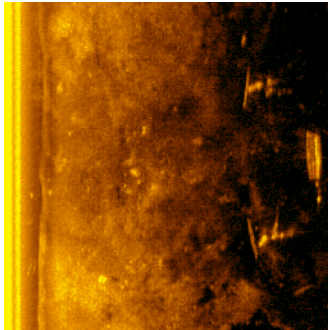
#### Contact0021

- Sonar Time at Target: 08/07/2008 17:42:54
- Click Position (Lat): 35.4121751
- Click Position (Lon): -76.6008317
- Map Projection: WGS 1984 UTM, Zone 18 North, Meter
- Click Position (X): 354,651.48
- Click Position (Y): 3,919,930.03
- Acoustic Source File:  
C:\Users\admin\Desktop\Pungo20080807\XTF\LINE-1-011.XTF
- Ping Number: 19616
- Range to Target: 23.59 Meters
- Fish Height: 1.46 Meters
- Event Number: 0
- Line Name: LINE-1-011
- Area / Block:

Target Description:  
Target Height = 0.00 Meters  
Target Length: 5.87 Meters  
Target Shadow: 0.00 Meters  
Target Width: 1.33 Meters
